## Hollfeld, parish church Mariä Himmelfahrt

### Description of the entire building

Dokumentationsformular zur Restaurierung – Durchgeführte Maßnahmen  
 abgleichende Überfang auf der Aussenseite  
 kath. Kirche St. Mariä Himmelfahrt – Feld 010b

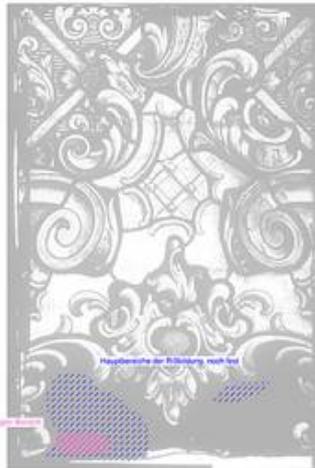
In the course of the further work, a particularly interesting phenomenon was the partially-chipped flash layer of the hand-blown authentic antique glass.
