ROTHKEGEL
Glasgestaltung · Glasrestauration · Glastechnik · Leuchtenmanufaktur · Leuchtentechnik

Lead netting consolidation instead of re-coating with lead. Also lead nettings are components of the original.

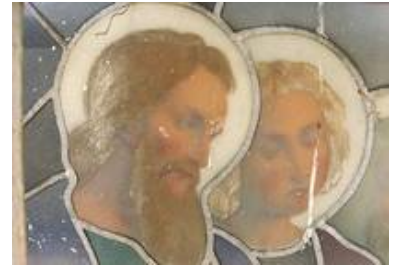
The filigree original lead netting of a glass painting in its previous condition (from the outside).

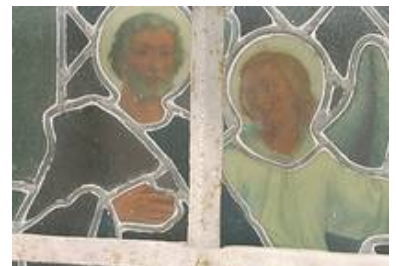
Another window in the same inventory was coated with lead according to the relevant historical specifications. The loss of the filigree character is clearly apparent.

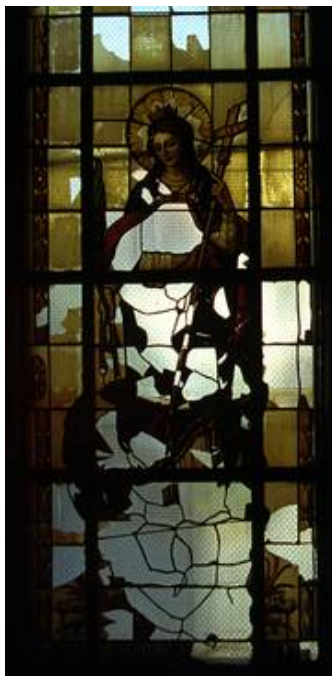
Even this severely damaged lead netting could be preserved in the course of conservation.

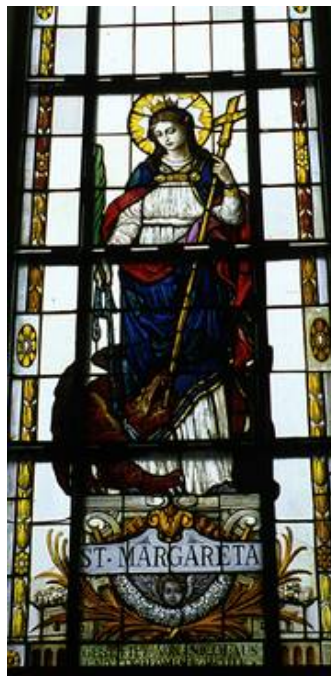
The same window, with the preserved lead netting and the reconstructions in the glass paintings.
