## Lead netting consolidation instead of re-coating with lead. Also lead nettings are components of the original.

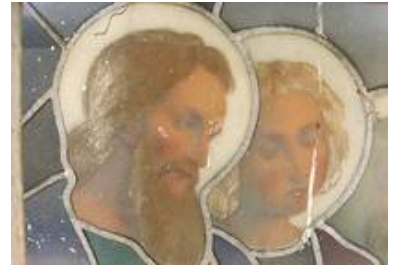
The filigree original lead netting of a glass painting in its previous condition (from the outside).
