Lead netting consolidation instead of re-coating with lead. Also lead nettings are components of the original.

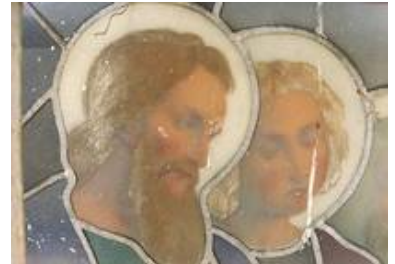
The filigree original lead netting of a glass painting in its previous condition (from the outside).

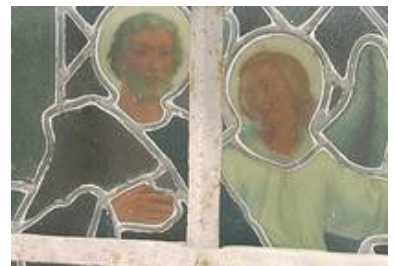
Another window in the same inventory was coated with lead according to the relevant historical specifications. The loss of the filigree character is clearly apparent.
