The re-glazing of the chapel in Callenberg Castle near Coburg

Extensive damage to the sandstones of the Castle Chapel also made the revision of the leaded glass inevitable.

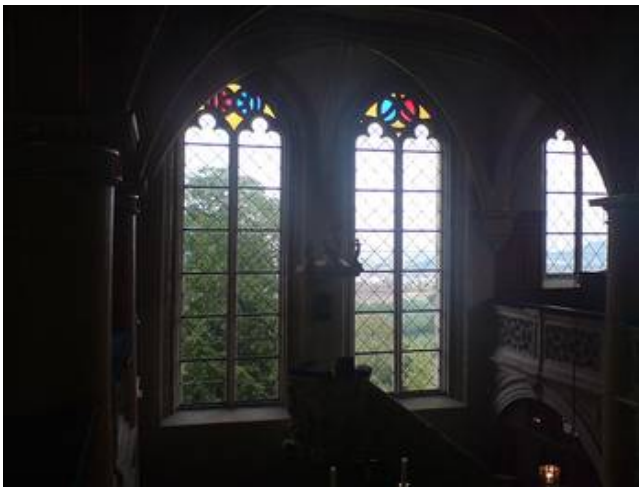
The windows after the re-designing

In the course of the work on the chapel windows, the decision was made to restore the arrangement of the windows to the design handed down in a painting featured in the chapel.

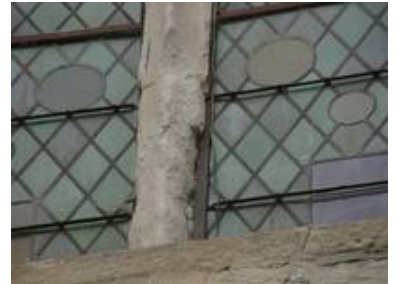
The damage to the Castle Chapel caused by stones was significant; readily recognisable is also the arrangement of the lead fields and the original positions of the glass painting panes.

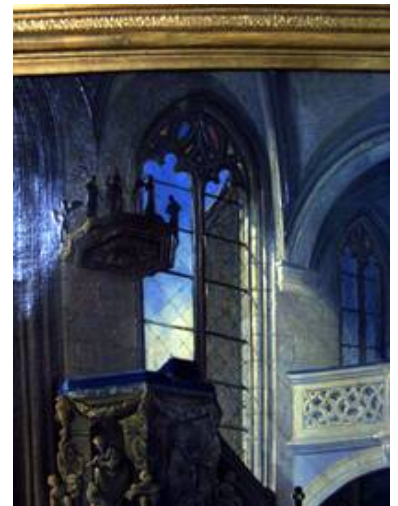
This painting clearly documented the original glazing.
