The fields of the Catholic local parish church Maria de Rosario

Selected protective-glazing system

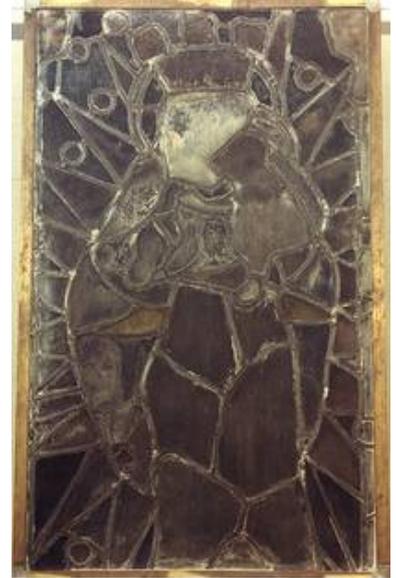
The exterior side of the medieval portrayal of the sun-crowned Madonna in reflected light displays the corrosion products typical to medieval panes.

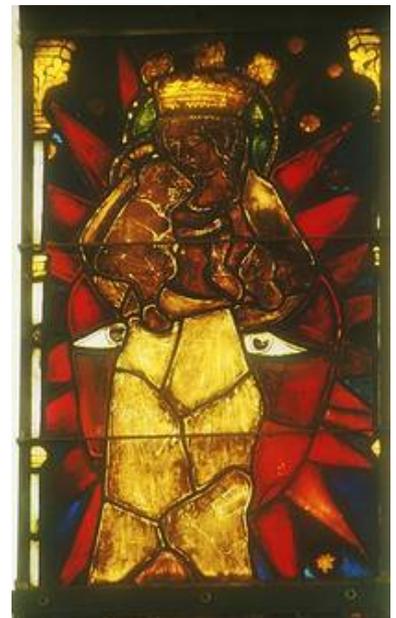
The interior in the transmitted light of the glass paintings makes the darkening due to browning recognisable.

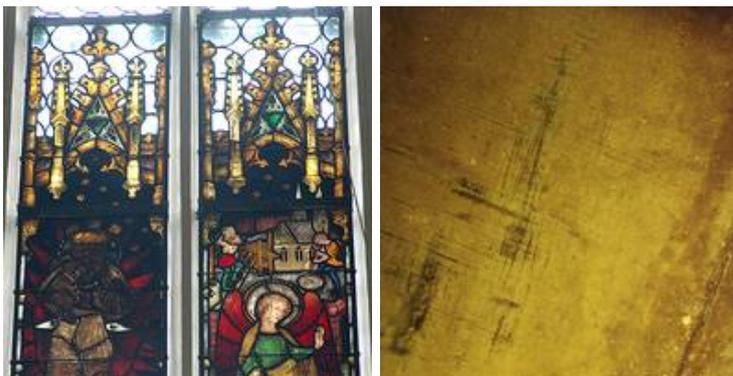
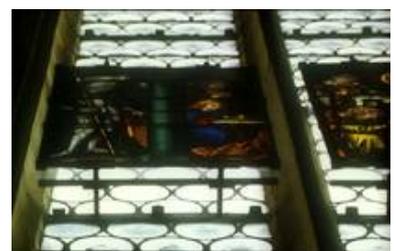
The existing leaded glass – which assumed the role of the protective glazing closing off the structural objects, was

To enhance these without changing the apperance of the church, additional intermediate layers were integrated into the existing restraint system.
