Condensation-collector chamfers: an important component on a window

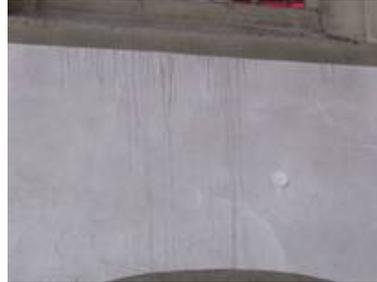
Run-off traces below a church window
