ROTHKEGEL

Condensation-collector chamfers: an important component on a window

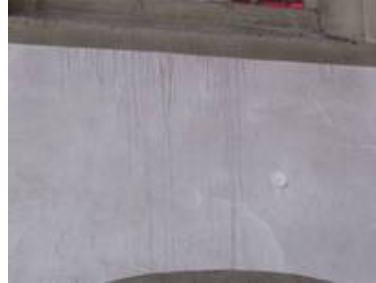
Run-off traces below a church window

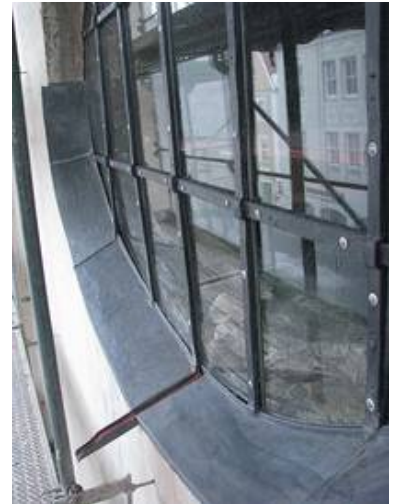
Logically, the assembly of a condensate-water chamfer is associated with a complete drainage and atmospheric-environment concept. In this process, all weak spots on the given structure should be considered. Here, this led to a comprehensive flashing of the window ledge, combined with a condensate chamfer featuring an exterior runoff fixture made of copper and framed by lead.

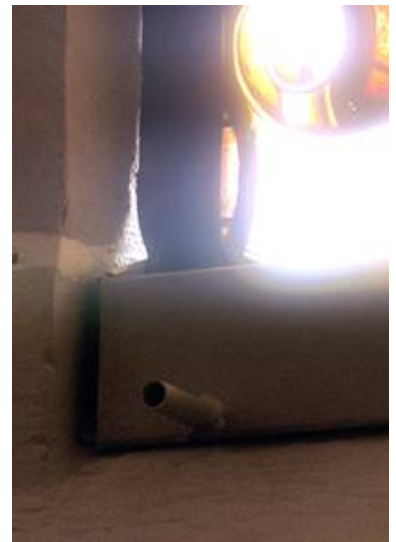
The drainage of a condensate chamfer can also take place into the interior. This process often enables easier maintenance of the chamfers, and – following the removal of a stopper (see one already removed in this image), the condensation can be discharged by targeted means; with that, the circulation of water in the building can be halted.

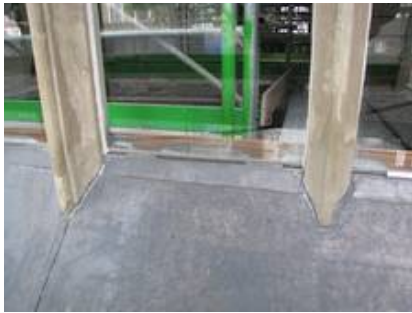
Illustration of a condensate chamfer made of copper and framed by lead on a window ledge covered with lead-sheet panelling.

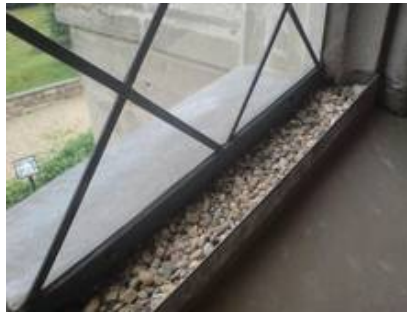
Illustration of a condensation-collector chamfer as an evaporation chamfer on a particularly geographically-exposed structure (which in any event would have been subject to the hazard of water being pressed into the interior due to the prevailing wind pressure).

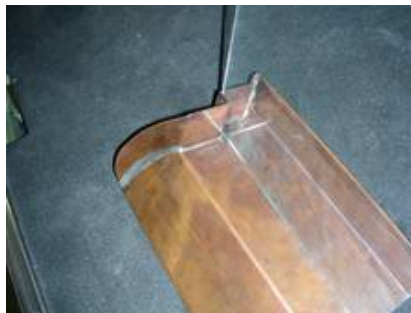
Illustration of a condensate chamfer made of copper; in this image, the exact adaptation to the masonry is readily recognisable.
