**ROTHKEGEL**

## Condensation-collector chamfers: an important component on a window

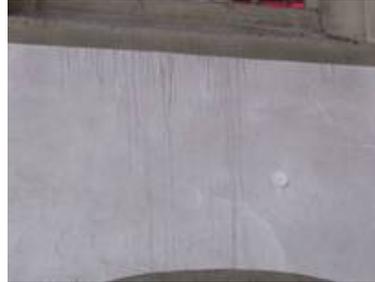
Run-off traces below a church window

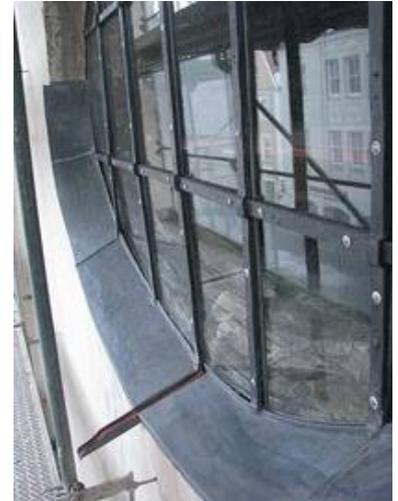
Logically, the assembly of a condensate-water chamfer is associated with a complete drainage and atmospheric-environment concept. In this process, all weak spots on the given structure should be considered. Here, this led to a comprehensive flashing of the window ledge, combined with a condensate chamfer featuring an exterior runoff fixture made of copper and framed by lead.

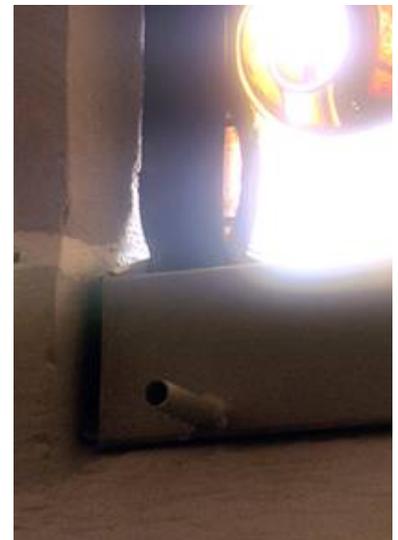
The drainage of a condensate chamfer can also take place into the interior. This process often enables easier maintenance of the chamfers, and – following the removal of a stopper (see one already removed in this image), the condensation can be discharged by targeted means; with that, the circulation of water in the building can be halted.

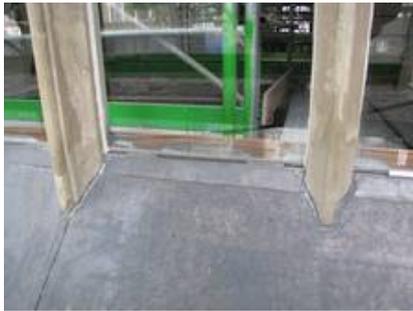
Illustration of a condensate chamfer made of copper and framed by lead on a window ledge covered with lead-sheet panelling.

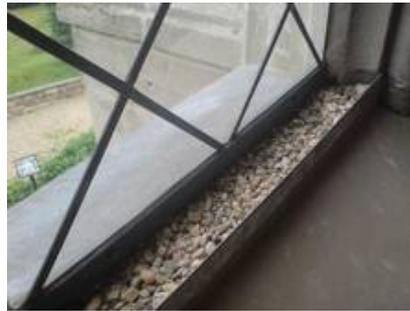
Illustration of a condensation-collector chamfer as an evaporation chamfer on a particularly geographically-exposed structure (which in any event would have been subject to the hazard of water being pressed into the interior due to the prevailing wind pressure).

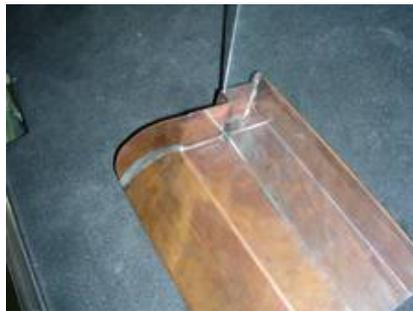
Illustration of a condensate chamfer made of copper; in this image, the exact adaptation to the masonry is readily recognisable.
