## Restoration of the original view of historic blind windows in the stairwell of the Residenz in Würzburg

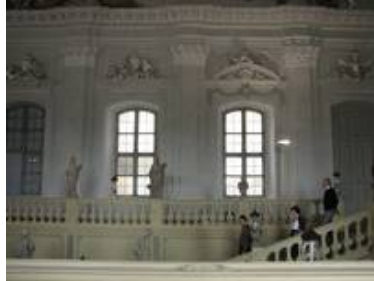
On the left, one can see one of the blind windows next to the windows facing towards the interior courtyard.

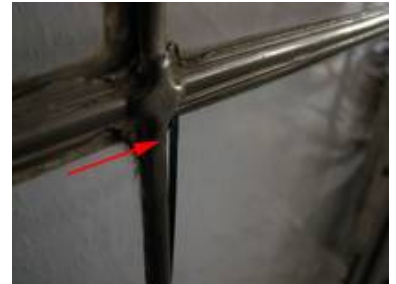
Due to the various levels between the extremely planar float panes and the original panes, the lead netting between them is subject to a heavy load and indicates some damage as a result.

Here, it is plain to see the load which the normal float-glass panes impose upon the original lead netting.

To preserve the damaged original lead netting and still securely hold the panes in place, lead seals were placed onto the lead nettings.

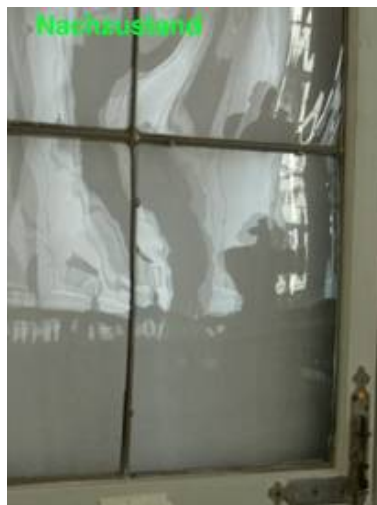
In the condition after the completion of work, this supplementation adapts ideally to the historic inventory.

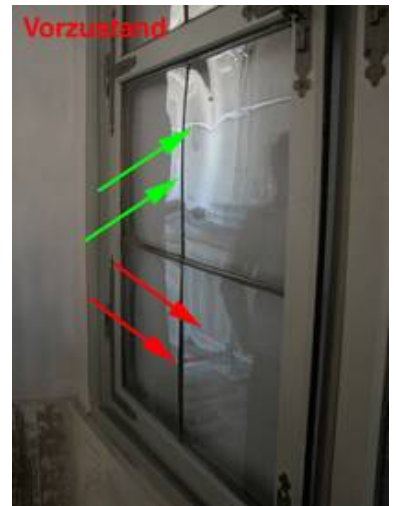
Since not all of the panes in the leaded glass are of historic origin – and in the past, simple float panes were used for repairs, the original surface structure is inhibited by extremely even reflections.

In the reflection, at first glance, the differences between the historic inventory and the repaired panes prior to the re-working performed by us is also plain to see.
