## Hollfeld, parish church Mariä Himmelfahrt

### Description of the entire building

Dokumentationsformular zur Restaurierung – Durchgeführte Maßnahmen  
 abgleichende Überfang auf der Aussenseite  
 kath. Kirche St. Mariä Himmelfahrt – Feld 010b

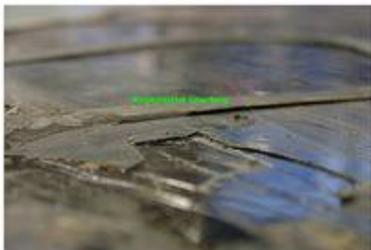
In the course of the further work, a particularly interesting phenomenon was the partially-chipped flash layer of the hand-blown authentic antique glass.

Dokumentationsformular zur Restaurierung  
 Beschreibung der durchgeführten Maßnahmen & der verwendeten Materialien  
 Besonderes
