ROTHKEGEL

The fields of the Catholic local parish church Maria de Rosario

Selected protective-glazing system

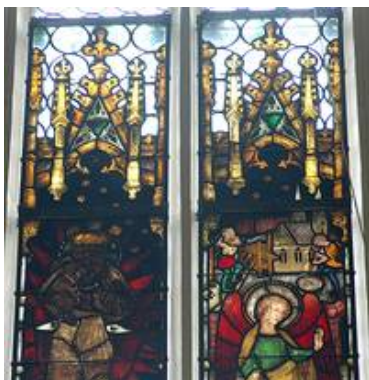
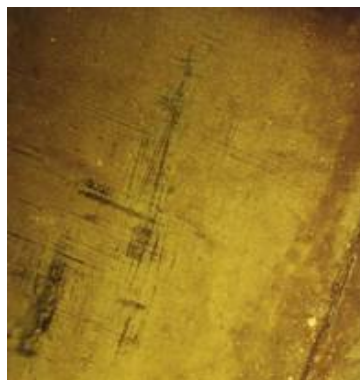
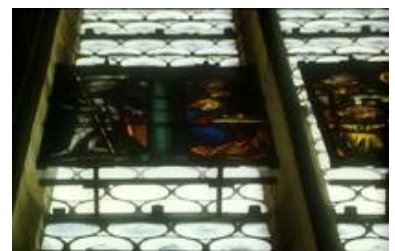
The existing leaded glass – which assumed the role of the protective glazing closing off the structural objects, was

To enhance these without changing the apperance of the church, additional intermediate layers were integrated into the existing restraint system.
