We conserve not only historic light fixtures

23.11.2009

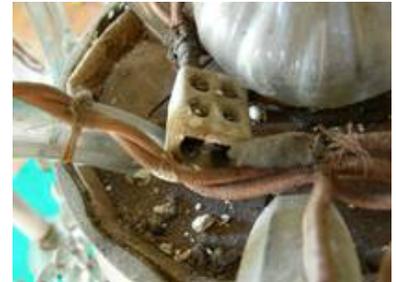
A clamping point on the chandelier from the Kugelhammer Castle (condition prior to conservation work)

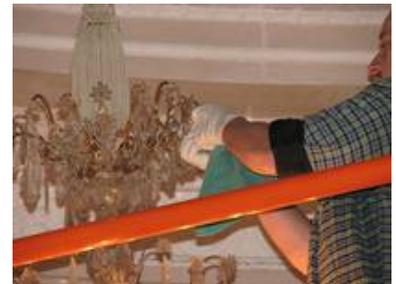
The cleaning of the chandeliers in Solitude Castle was performed in situ, as complex and painstaking handiwork
